MISSOULA URBAN DRAINAGE
INTERSTATE HIGHWAY

PROJECT 1-90-2(27)103 UNIT 1

INVESTIGATION REPORT
MISSOULA URBAN DRAINAGE
NEAR
MISSOULA, MONTANA

Prepared By
MORRISON-MAIERLE, INC.
Consulting Engineers
Helena, Montana

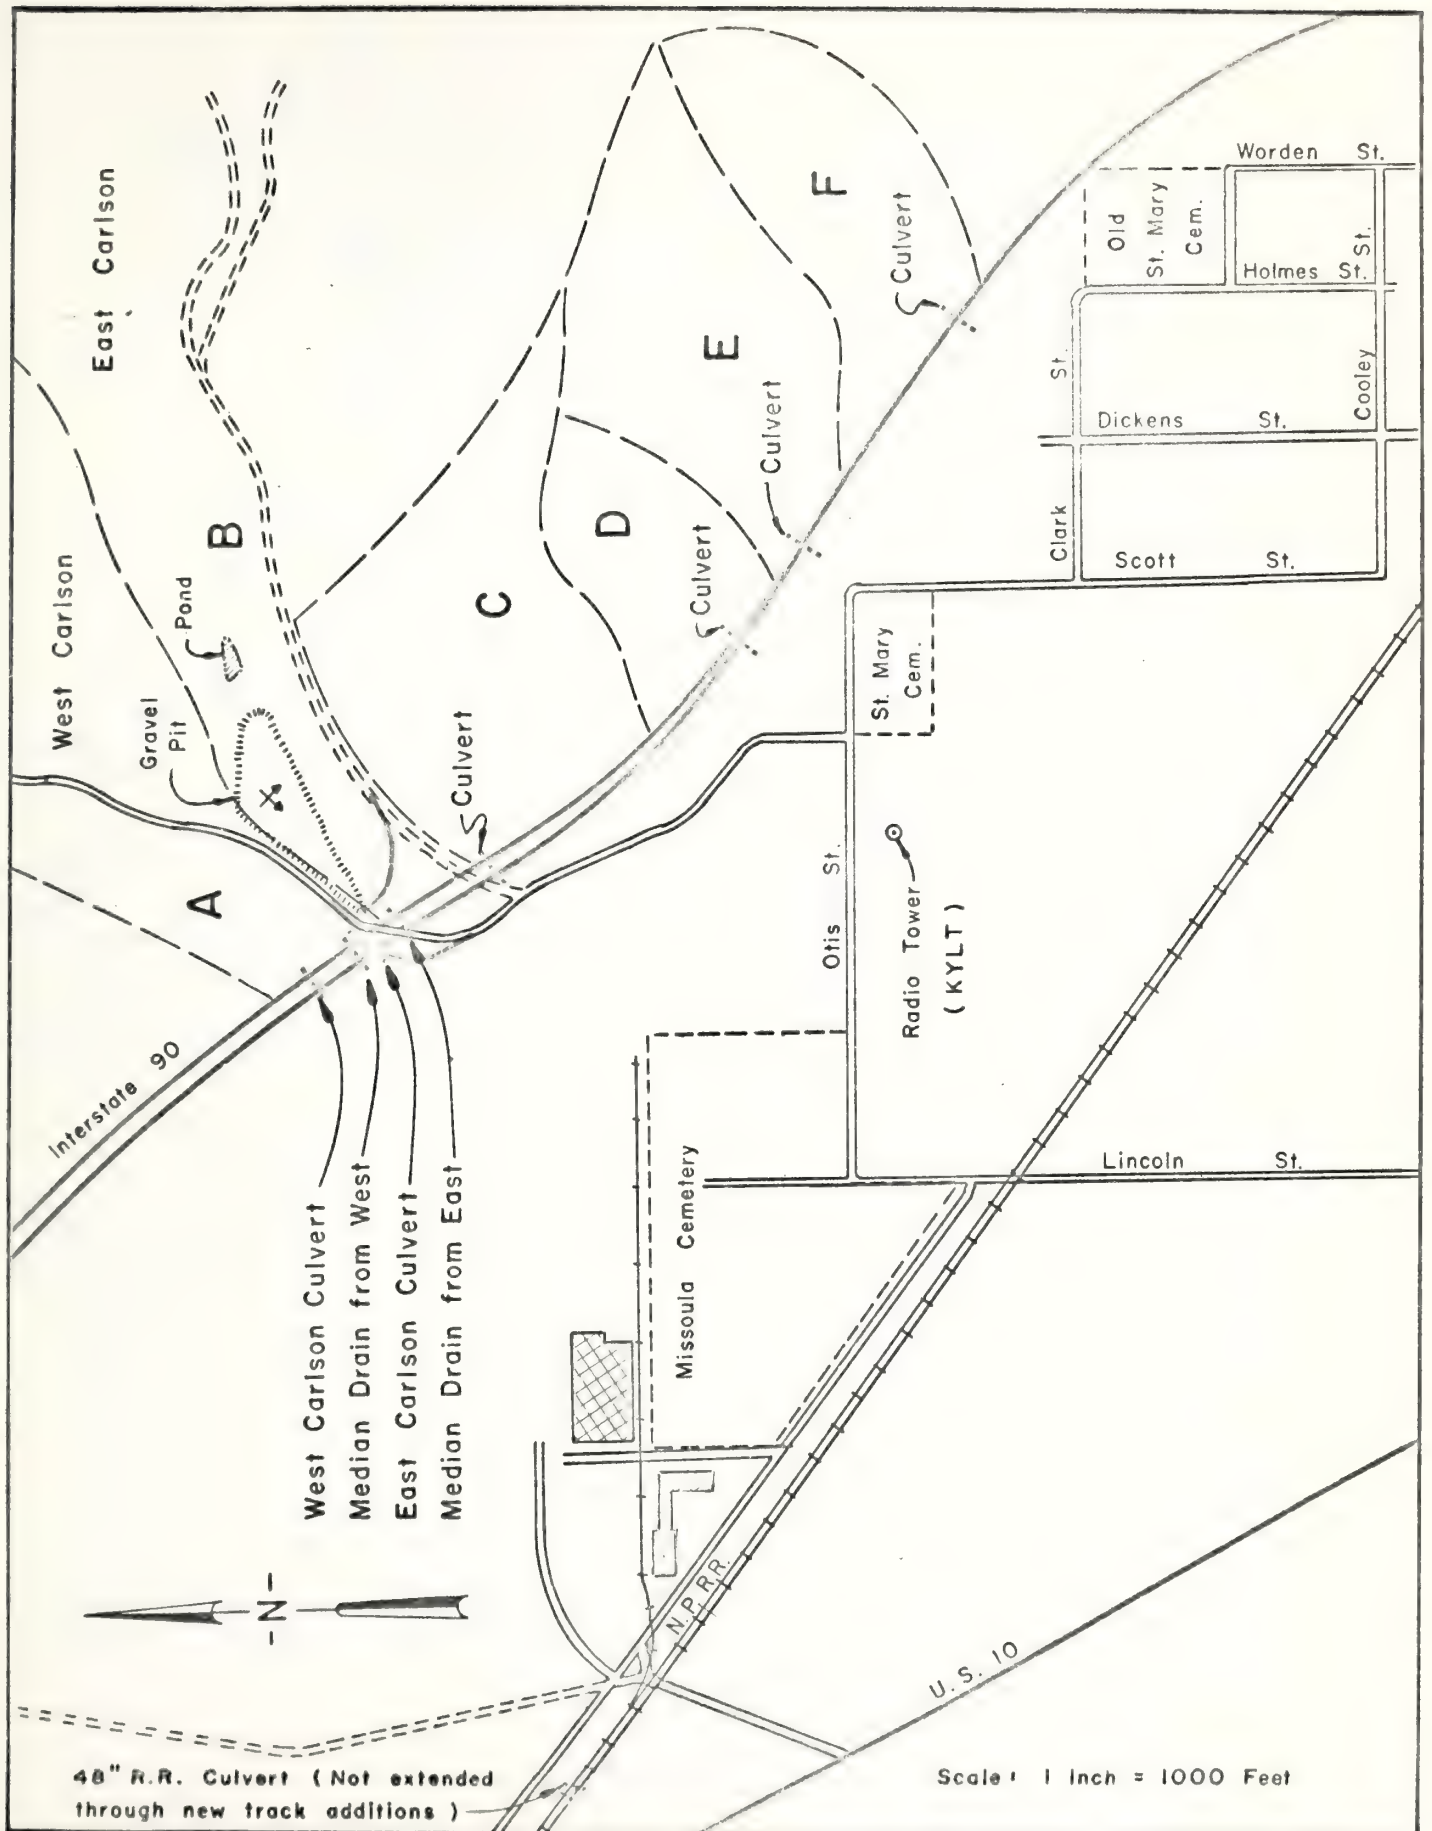
DRAINAGE SKETCH

The area labelled D in FIGURE 2 is that of a short steep ravine. The drainage from this area of 28 acres is carried under the Interstate in a 24 inch culvert which discharges in the former channel about 600 feet north west of the corner of Otis and Scott Streets. The outlet of the culvert is on an alluvial fan created by previous deposits of the natural channel. Flow beyond the culvert would move southwestward and probably collect near the northeast corner of Shakespeare and Otis Streets. The photographs of March 11, 1966 and observations of June 14, 1967 indicate that little or no water reached that

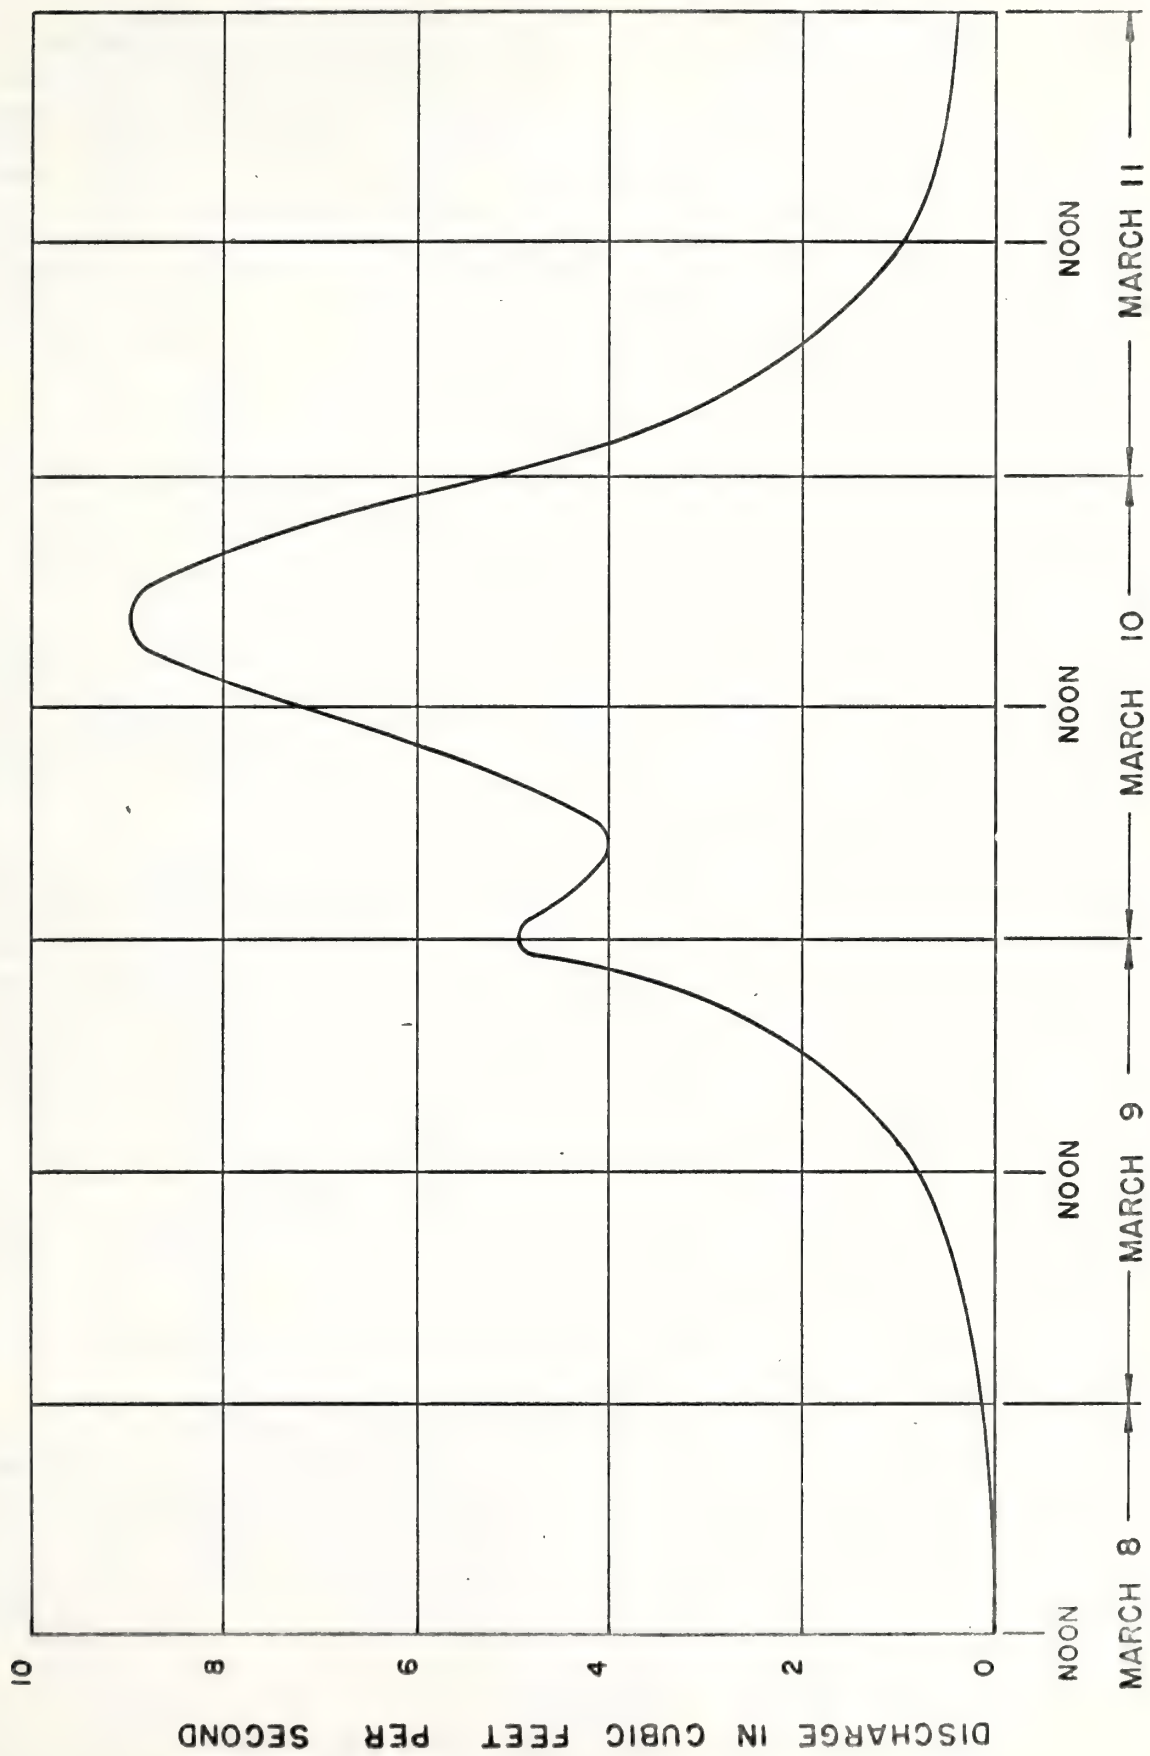
DERIVED HYDROGRAPH - MARCH 8-11, 1967

stream end. A photograph of March 11 shows a flow of about 0.5 cfs. The pond on East Carlson Gulch would have exerted a little levelling influence by storing about 1.3 acre feet of water and permitting some percolation to groundwater. The scour of the earthen spillway was probably not sufficient to have caused a significant increase in flow during the latter part of the runoff period. The combination of flow from the two median drains and a sidehill and gutter drain with the East Carlson Gulch flow may have resulted in a peak flow of about 9 cfs at a point near the northeast corner of the Van-Evan log yard and the frontage road. The hydrograph FIGURE 6 depicts that flow.
